REMEDIAL WORKS FOR THE BURNLEY TUNNEL, MELBOURNE

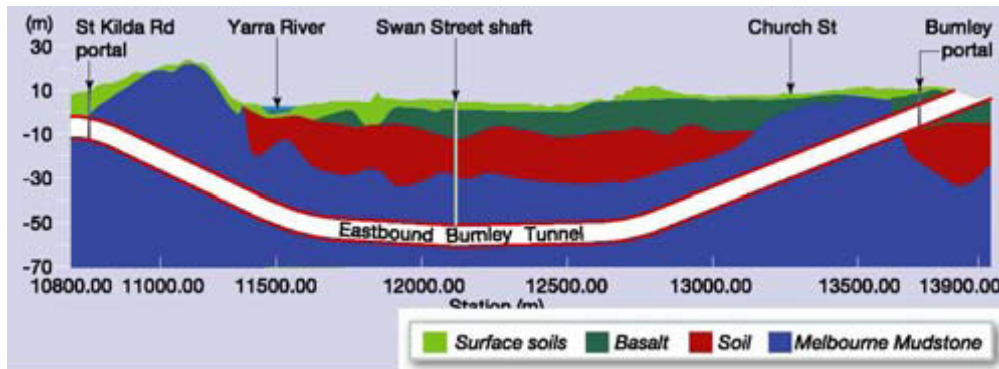
Figure 1 Summary of Geology along the Burnley Tunnel.

The Burnley Tunnel in Melbourne is about 3.5km long and passes at a depth of 60m beneath the Yarra River (see Figure 1). In about mid-1999, prior to the tunnel being opened, problems developed with the invert lining within parts of the tunnel. These problems were widely canvassed in the Media and aspects of the remedial works were published in the Melbourne Age. This article deals with technical facets which are in the public domain. It does not deal with matters which were subject to dispute between various parties associated with the tunnel.

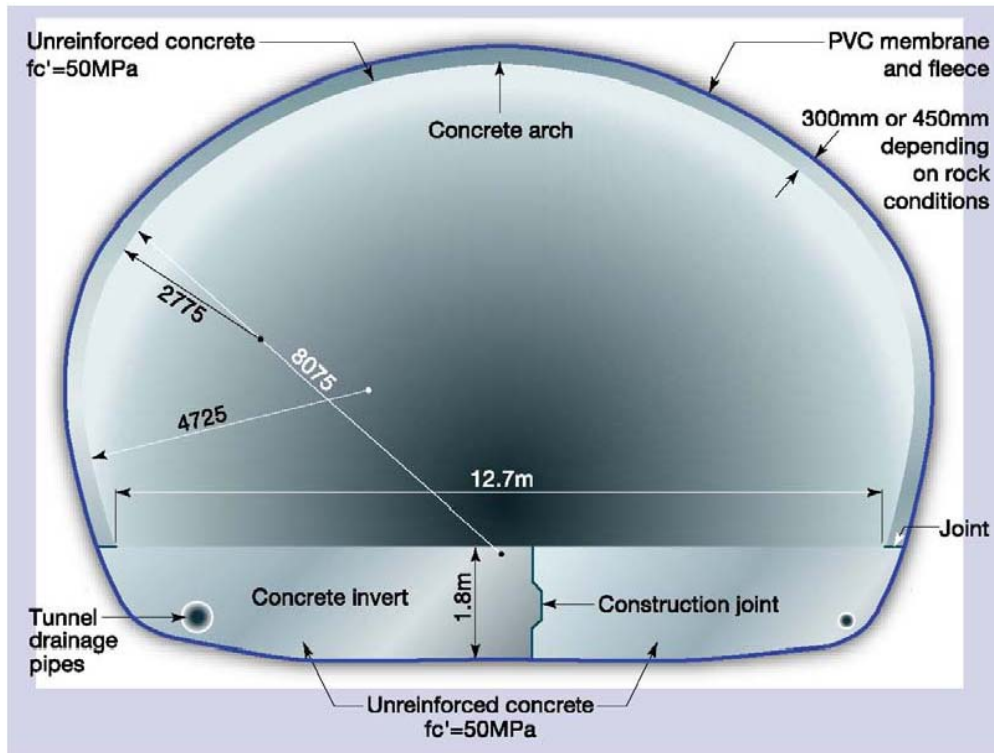
Figure 2 shows a cross-section through the final lining of the tunnel (References 1, 2 and 3). The lining is fully tanked by means of a continuous PVC membrane between the Primary Lining (rockbolts, sets and shotcrete) and the unreinforced concrete Secondary Lining.

Figure 2 Cross-section through the designed permanent lining of Burnley Tunnel.

The tunnel invert comprised thick slabs with a slightly arched underside. There is a longitudinal joint near the centerline as shown in Figure 2. The slabs are 12m long along the tunnel, i.e. there are transverse joints at 12m intervals along the invert.

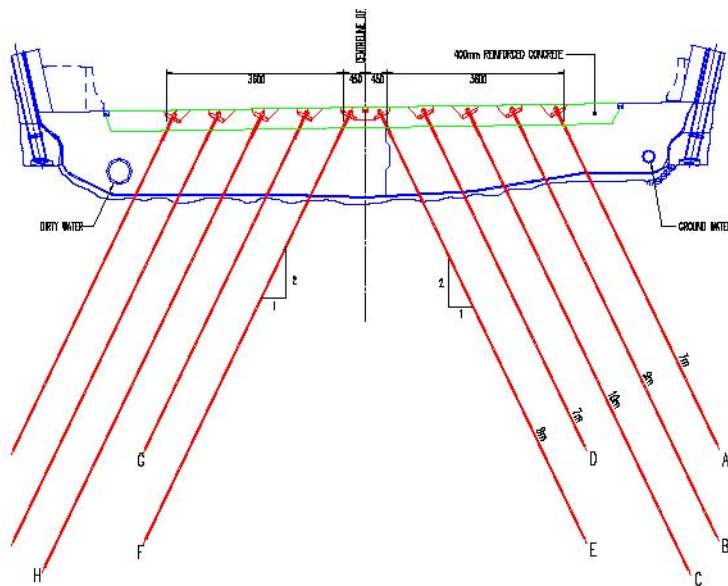
Figure 4 shows that these remedial measures comprised:

- Trimming 400mm of the existing invert concrete,
- Installation of sufficient anchors to resist the uplift pressures (typically 96, nominal 100 tonne working load anchors per 12m long by 12.7m wide invert slab),
- Casting of new reinforced concrete capping slab, and
- Stressing of the anchors.

With some modifications, the multi-anchor design was adopted for slab 55 and for slabs 95 to 116 (see Figure 4).

Figure 4 Multi-anchored slabs.

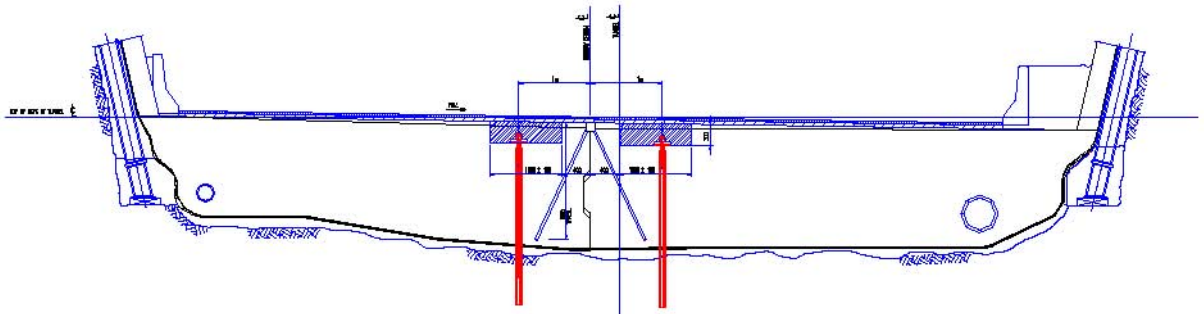
Over the remainder of the tunnel, except for slabs 1 to 12 and 177 to 181, remedial work comprise central twin anchors, at average longitudinal spacing of about 1.2, as shown in Figure 5.

Figure 5 Twin Anchor Design.

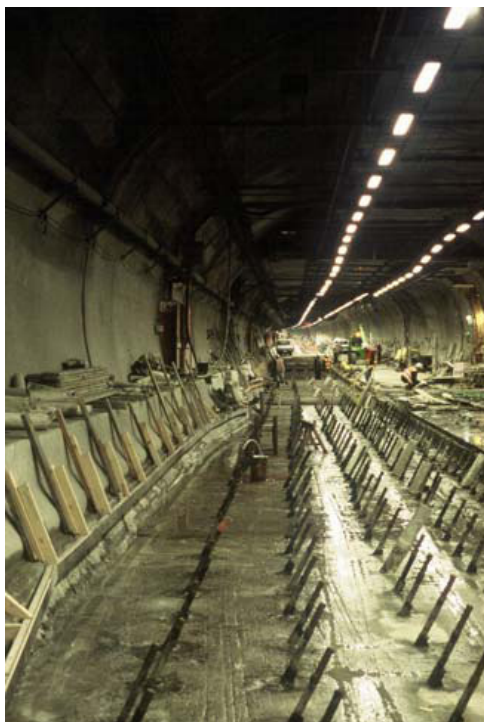
Photo 1 shows part of the central section of the tunnel during multi-anchor installation and Photo 2 shows a patch of completed 46mm diameter VLS stressbar anchors within the reinforced capping slab, prior to casting the slab and stressing of the anchors.

Photo 1 Drilling and installation of anchors.

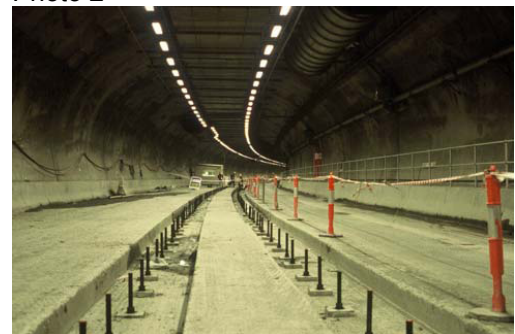
Photo 3 shows a typical length of twin-anchor remediated slabs.

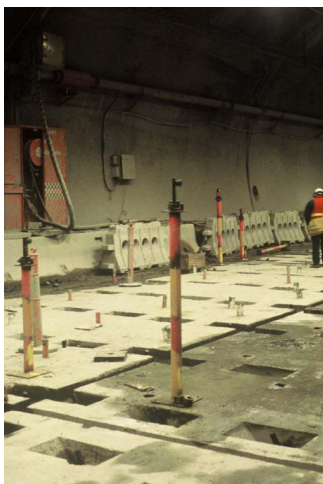
The prisms were mounted on posts which ranged in height from about 1.2m to 2.0m. There were four prisms for each half of an invert slab (a half slab being defined by the near-central longitudinal joint and the 12m-spaced transverse joints). Photo 4 shows the typical post arrangement. Survey distances were typically less than 30m.

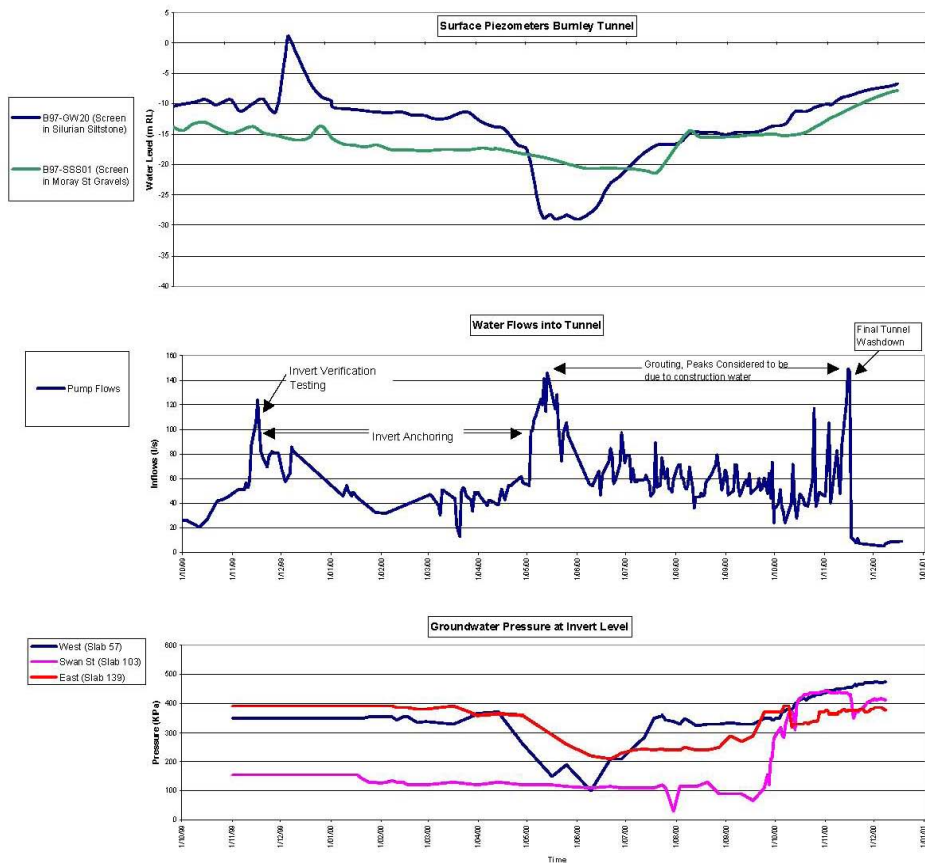
A full description of the grouting works is outside the scope of this short technical history. The work too 5 months, commencing in mid-July 2000. Throughout this period it was very difficult to measure whether we were being successful because water introduced into the tunnel for drilling, and other construction processes, made it impossible to measure the natural inflows (see Figure 6).

Figure 6 Inflows and Groundwater Pressures.
